# Production status of the SBS GEM modules

Latest production issues and fixes

# Production status of SBS Back Tracker GEMs

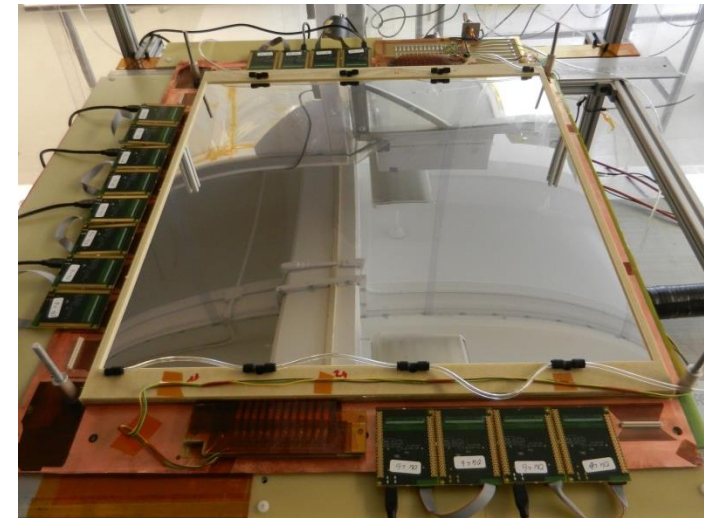
- Use aluminized gas window foil and set it to the same potential as the drift cathode → Faraday cage like to prevent charges accumulation on the gas window as well as the top Kapton layer of the drift
- Tested with SBS-BT-GEM proto I with x-ray source at high rate ( $> 1 \text{ MHz /cm}^2$  equivalent MIP).
  - Without the HV on the gas window → foil collapse after a few hours of x-ray exposure
  - **With the HV on, we did not observe any collapse after 5 days of almost continuous exposure**

Aluminized Kapton replace plain Kapton in production chambers starting with SBS-BT-GEM prod#13

- Prevent the collapsing of the gas window foil onto the drift cathode
- **Aluminized Kapton ( $\sim \times 10$ ) more waterproof than plain Kapton  $\rightarrow$  reduce water contamination**
